Lumbar Valve Replacement

Model & year: 95-01 7-Series, U.S.

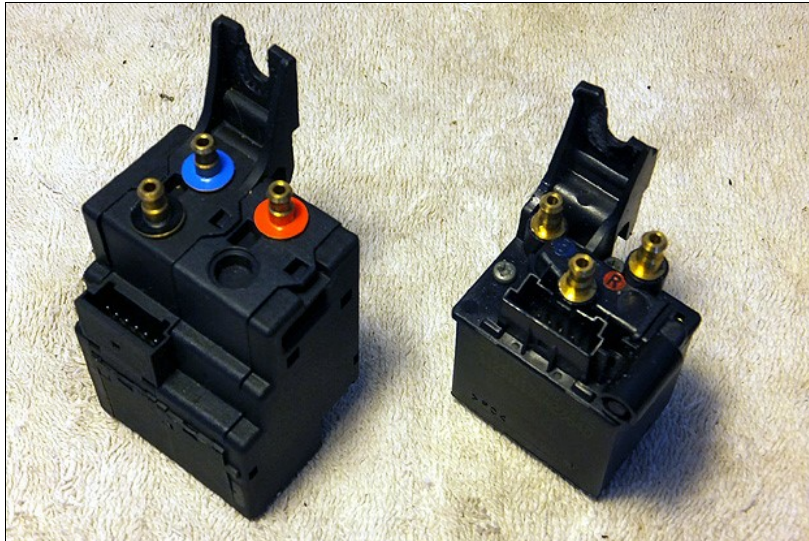
- (1) Lumbar Valve Unit, p/n 67 66 8 385 632 list: \$129, used: about \$25 (samples shown above)

I discovered the valve units come in at least two different sizes and are interchangeable (see image above). New valve units are expensive, so most people turn to used parts instead. However, only with a new part can you be assured of correct check-valve operation. The seatback panel will need to be removed for access.

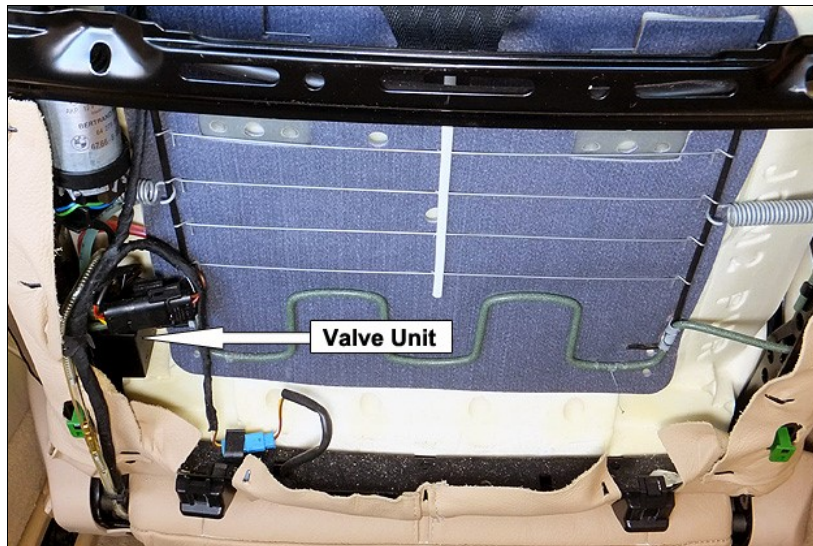
3) Locate the valve unit in lower left of seatback. See image:

The valve unit will be partially hidden by various other wires and connectors; unplug and move them out of the way.

The air line which is clear or transparent is the main air supply coming from the air pump under the seat, while the blue line controls the upper lumbar chamber and the red line controls the lower chamber. (See image below.)

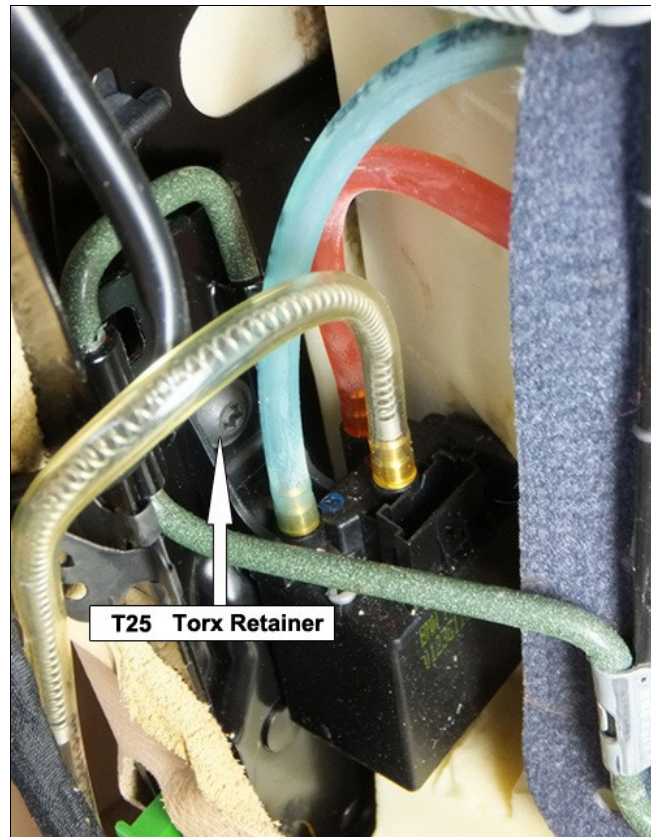
4) Unplug valve unit electrical connector. Prying carefully with a small screwdriver for leverage may help in this confined space. Needle nose pliers may also help remove the plug.

5) Remove the T25 retainer screw and pull valve unit up and off its retaining slot in the seatback frame. See image above. Position the valve unit so that the air lines may be easily reached.

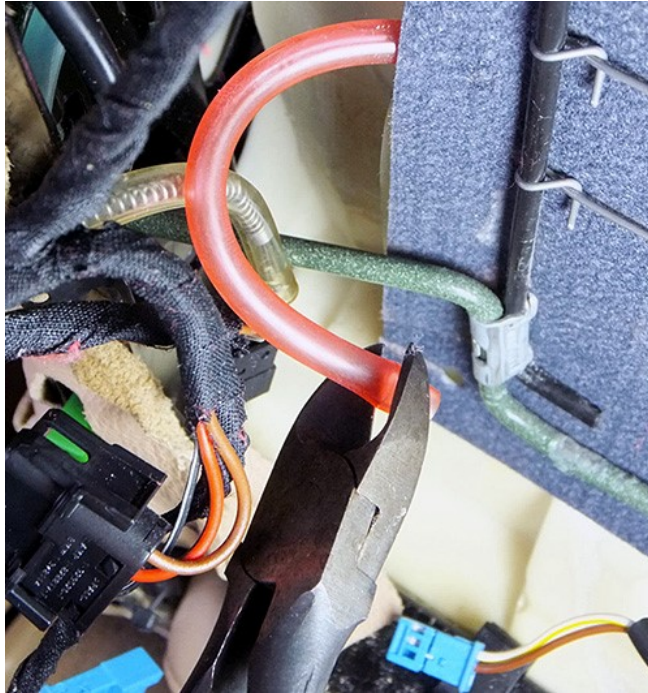
7) In order to ensure an air-tight seal with the replacement valve unit, snip the deformed, bloated ends of all three air lines where they connected to the old valve unit (if not already done in step 6), as illustrated below:
