# Sunroof Water Leaks

Model & year: **95-01 7-Series, U.S.** (with steel sunroofs)

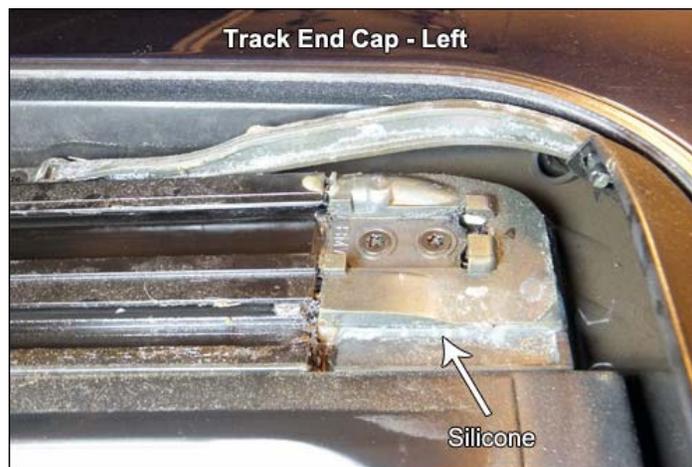
The leak source was the sunroof track end caps. It appears BMW is aware of this and has attempted to resolve it with silicone sealing around the end cap perimeter (see image below). But I've discovered the silicone treatment may not be sufficient.

The solution is to replace the outer seal, re-caulk the end caps, and clear the front drain outlets.

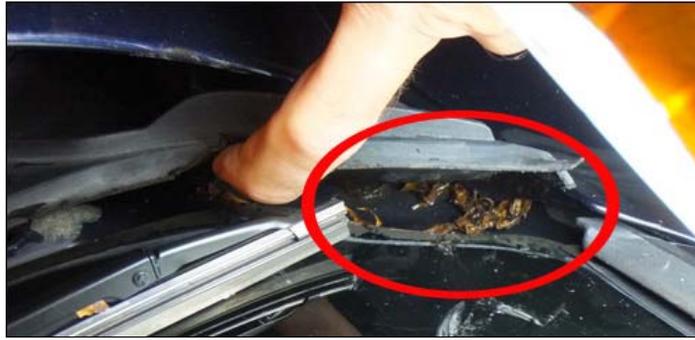
Additionally, the drain outlets at the base of the windshield may become restricted with debris:

**2)** Lift up cowl corners and inspect for debris. Clear debris.

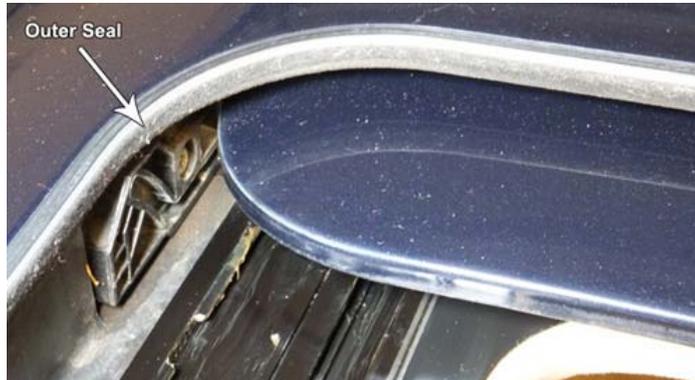
But there's even more. The sunroof's outer seal is the first line of defense against water intrusion. But over time, the seal degrades, allowing much more water to pass. The seal part number has been superseded (updated) by BMW no less than 5 times, indicating this is a known problem. It's likely the sunroof seal on your car hasn't been updated since it left the factory.

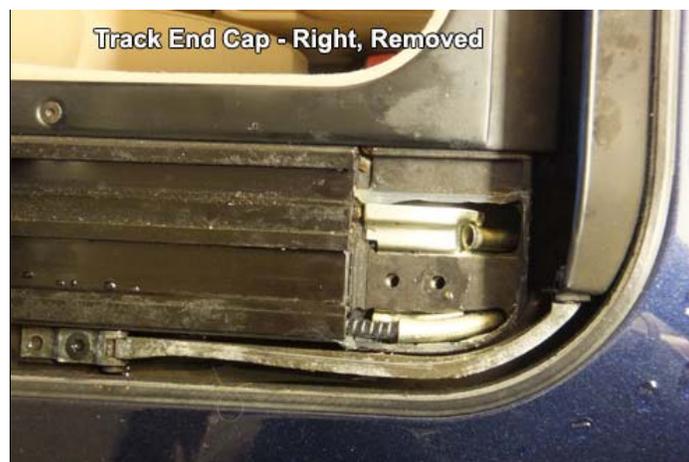
1) With sunroof open, remove end caps after removing the two torx retaining screws. This will make it easier to clean and prep the area for caulk, and/or to remove old caulk. See image below:

2) After cleaning, apply a bead of silicone caulk to both mating surfaces and reinstall end cap. Apply additional silicone to inside edge and between track gap and end cap. In other words, caulk all sides of end cap generously.

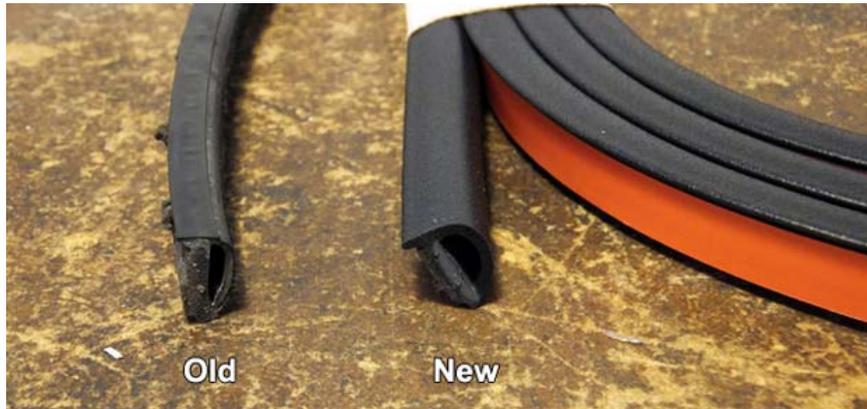
Your old seal probably has a compressed profile after many years of use (see image below), along with degraded materials due to exposure and wear.

**1)** Remove old seal beginning at rear center seam. Grab and pull strongly to separate seal adhesive from roof opening.

**3)** With roof opening clean and free of old adhesive, install (bond) new seal beginning at center rear.

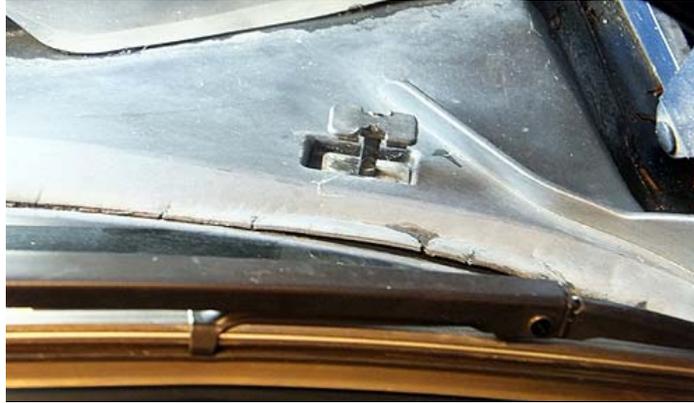
**1)** Open hood. Using needle-nose pliers and a small screwdriver, pry up and remove the 2-piece cowl retainers at bottom corner of windshield. See image below:

**3)** Re-install cowl retainers.
