Alarm Siren Replacement

Model & year: **96-97 8-Series, U.S.**

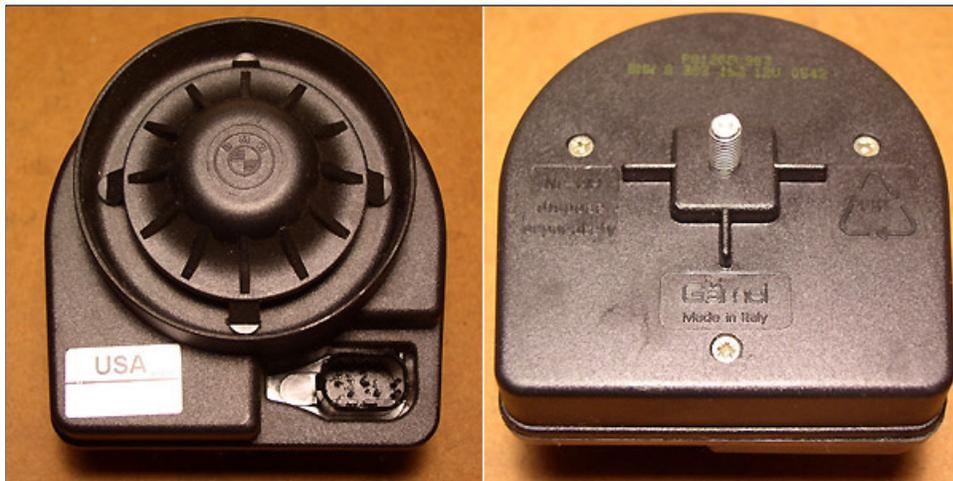
- Alarm Siren ("Alternate Power Siren"), p/n 65 75 8 383 153, price: \$147 (list)

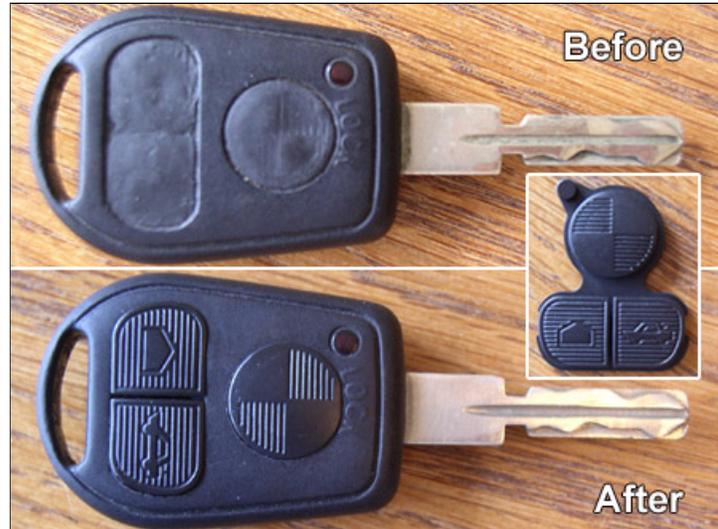
TIP: Is your alarm key worn out?

Give it new life with a replacement rubber key pad! They're available from various eBay vendors for about \$10 with shipping (search keywords: "BMW key pads"). It's also a good time to replace your key battery.

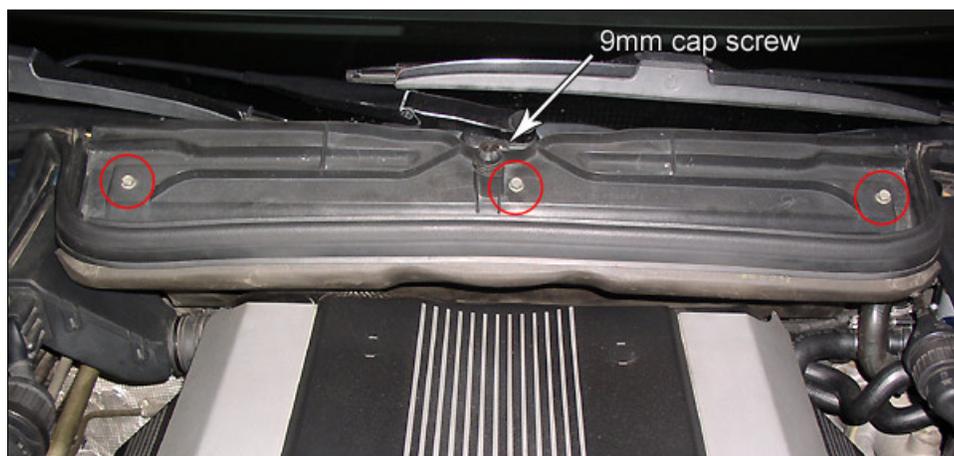
1) Working under the hood, lift off the rubber gasket surrounding the cowl edge and fold it against the windshield to keep it out of the way (I used a heavy towel to hold it down. You could also place the left wiper arm over it). Then remove upper plastic trim cover by first removing the three 10mm securing screws and optional 9mm cap screw at base of right wiper arm. See image below:

With trim cover removed, the cabin air filters will be visible. You may leave them in place.

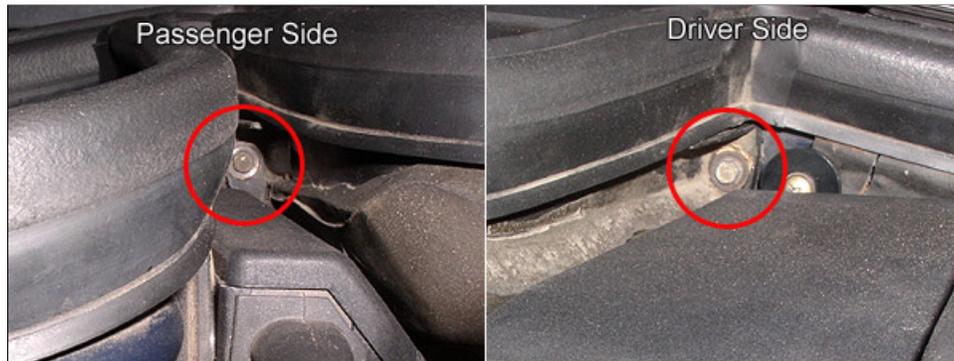
2) Using a 7mm socket, remove the single securing screw on each side of the cowl (2 total). Be careful not to drop the small screws into the engine bay (you may want to magnetize your socket). See image below:

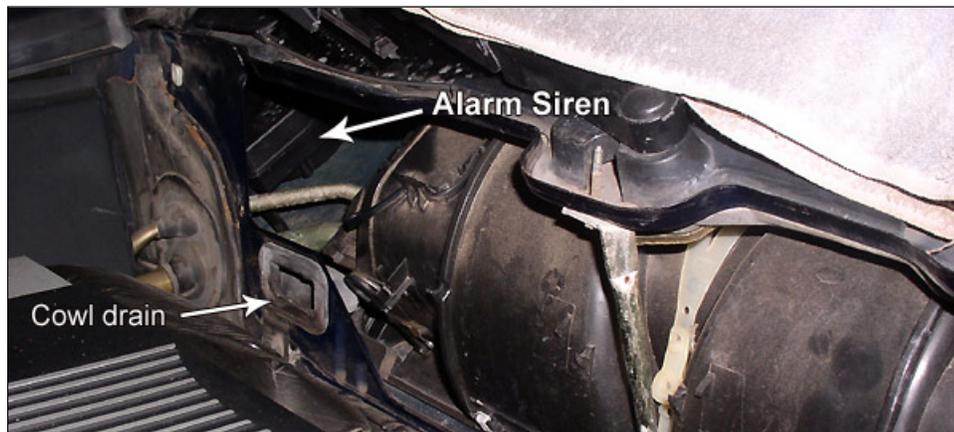
3) Lift cowl up and off. Set aside. Hiding inside the lower right (passenger) side you will see the alarm siren:

It is facing down, and secured on a bracket with a single 10mm nut from above.

4) Place a protective cover over the right (passenger) fender to prevent scratching. Lean over fender and reach blindly up and inside cowl to feel for the siren's 10mm nut. Remove nut using a small wrench (be careful not to drop nut inside!). Work siren down and off securing bracket. It is pinned between the bracket and floor of cowl and must be squeezed out by force. Once released, pull siren toward center of cowl. When fully in view, turn it over to unplug connector. Remove siren.
